InSight Condition Report

2017 FIAT 500e Hatch

3C3CFFGE6HT502904 31,530 mi | Front Wheel Drive | Electric Motor | A/T | Hard Top | Premium Synthetic
 Lane/Run 4/5 Facilitation Manheim San Francisco Bay Seller CHRYSLER CAPITAL

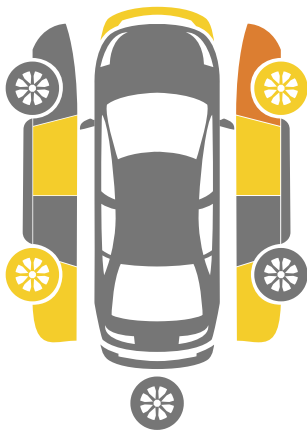
Damage Overview

Exterior (10)

Front Bumper Cover	Scratch Heavy 2" to 3"	Paint and Body Requires Conventional Repair

Description	Condition Severity	Type	Image	Additional Info
● LF Door	Dent/No Paint Dmg PDR/1	Cosmetic Conventional Paint and Body Not Required		
● LF Tire	Worn Acceptable	Miscellaneous		
● L Qtr Panel	Dent/No Paint Dmg PDR/1	Cosmetic Conventional Paint and Body Not Required		
● LR Wheel	Curb Rash 1/2" to 1"	Miscellaneous		
● R Qtr Panel	Mult Dents/No Paint Dmg PDR/2	Cosmetic Conventional Paint and Body Not Required		
● RF Door	Mult Dents/No Paint Dmg PDR/2	Cosmetic Conventional Paint and Body Not Required		
● RF Fender	Dent/No Paint Dmg 1" to 2"	Paint and Body Requires Conventional Repair		
● RF Wheel	Curb Rash 5" to 6"	Miscellaneous		
● RF Tire	Worn Acceptable	Miscellaneous
